PROPOSED REPAIRS

**PAINTED ROCKS  
DAM**

DRAFT ENVIRONMENTAL  
IMPACT STATEMENT

AUGUST 1976

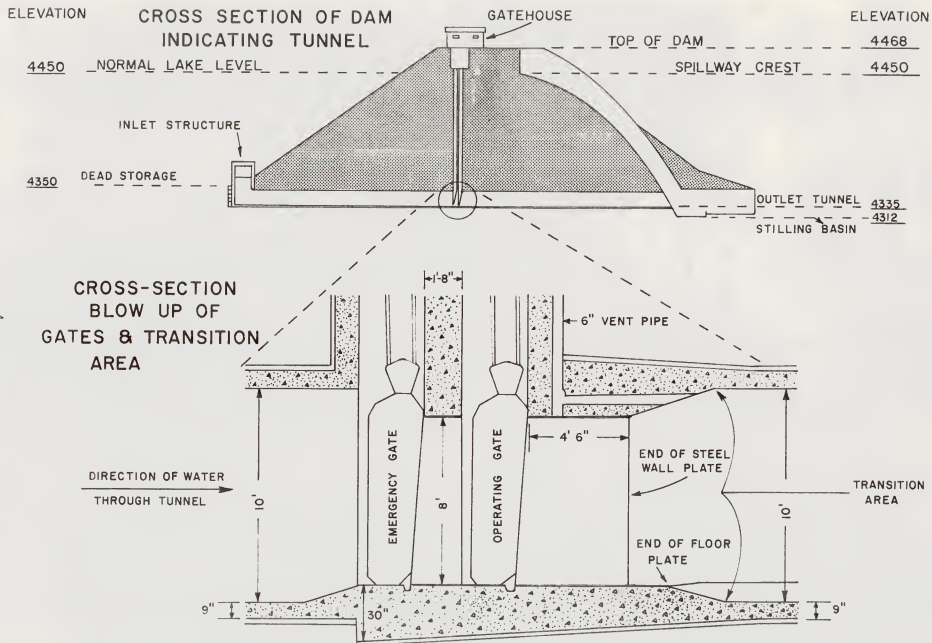
Figure 3. CROSS SECTION OF DAM AND GATE AREA

The earth-fill dam, over 140 feet high and 800 feet long with a volume of 850,000 cubic yards, retains a three-mile-long reservoir. The concrete spillway drop at the right abutment of the dam has a capacity of 26,000 cubic feet per second (cfs). A concrete-lined rock outlet tunnel, in an almost circular shape with a diameter of approximately 10 feet, emerges from the dam at the base of the spillway (see Figures 2 and 3). There is a self-sealing rectangular slide gate used in the normal operation of the dam and another to be used in emergencies when the first gate is being repaired. These identical gates measure approximately five feet wide by eight feet high. Between the rectangular gate and the circular tunnel there is a *transition area*.\*
